Report No: MDP000487

Client	Harvest Operations Corporation	Inspection Date	Jul 17, 2009		
Prov. Reg. #	AB 3055474	Inspection Type	VE / VI		
Equipment Type	FWKO	LSD	AB 12-15-040-08W4		
Tag/Equip.	V-130	Location	Amisk		
Status	In Service	Area	Hardisty East		
Manufacturer	PROCESS INDUSTRIES INC.	Year Built	1994		
Serial Number	94-C2883-3000	Service	Sour		
CRN #	M6442.2	Manway	None		
Comp/Unit Id		Coating	No		
Nat.Board #		Owned By	Harvest Operations Corp.		
Interim Insp'n		Interim Type			
Next Inspection	2013	Next Insp Type	VE / VI		
Length	480 in	Height			
Volume		RT	1	HT	No
Job No.	09-0279	Client Reference			
Foreman	Darren Olofson				
ABSA	Plant: H Vessel: K Process: W Special: B	ASME	Sec. VIII div. 1		
History Log	AB-10 submitted April 6, 2009 - Vessel owned by Harvest

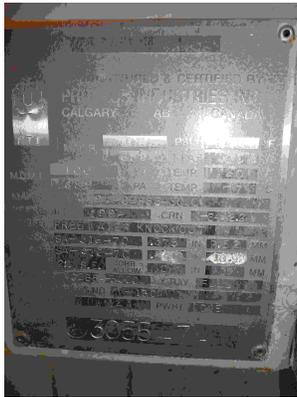
Figure: 1

Nameplate General Overview

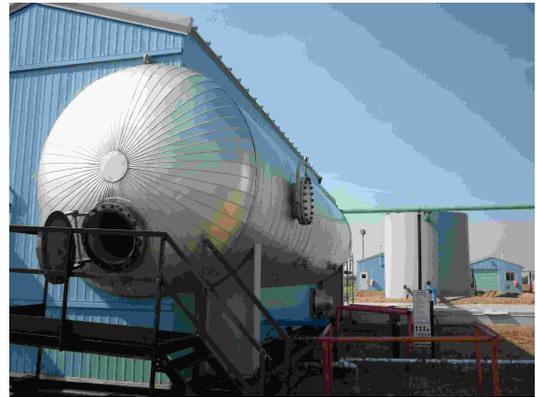
Figure: 2

The vessel was located inside (30%) and outside (70%) a building. The nameplate was legible and securely mounted to the vessel. The vessel was identified per A-number and serial number stamped on the nameplate of the vessel. The heads, shell, nozzles and bolting appeared to be in good condition. There was no stress evident on piping or nozzle connections. There was no damage or distortion evident on the vessel surface. The vessel was insulated outside the building. The vessel was painted inside the building and the paint was generally in good condition. There was scattered external corrosion visible on the vessel surfaces. The gauges were in good condition.

General Overview Outside Building

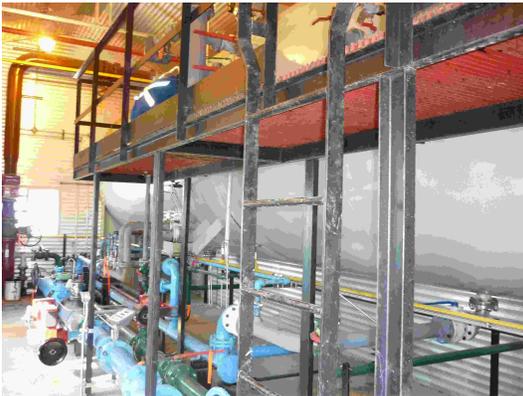
Figure: 3

General Overview Inside Building

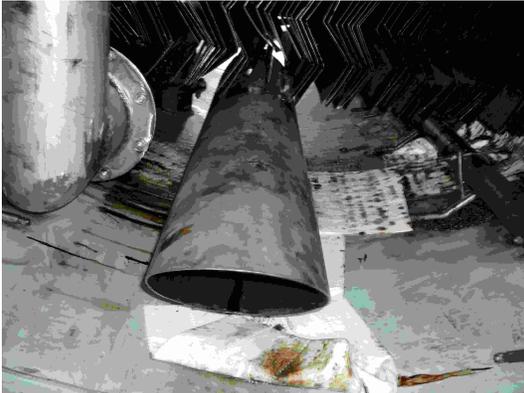
Figure: 4

general condition of internal components.

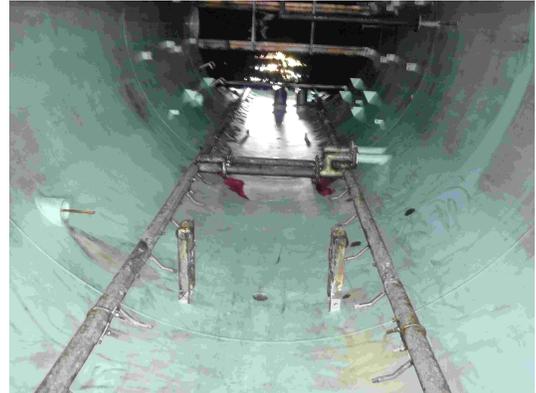
Figure: 5

The anodes rods were only stumps remaining. The anodes were 100% consumed. There was some steel exposed at the structural clips . Some corrosion was found on the bottom of the coalescer plates. The vessel was 100% coated. There were a few locations where the coating requires repairs. The exposed steel was not corroded. The internal de-sand lines were in good condition and secure. There was scale forming on the lines. The coalescer was secure. The back end was in good condition with no deficiencies on the shell on head. There was one coalescer sheet that was severely corroded at the bottom. The oil box and door were secure and in good condition. The internal piping was stainless steel and in good condition. There were no isolation kits installed.

image showing general condition of the vessel internal

- 1) Change anodes after 2 years.
- 2) Repair marked coating chips.
3. The vessel is otherwise fit for service.

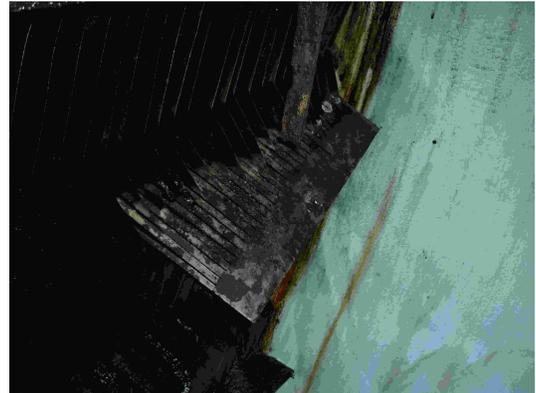
Figure: 7

coalescer sheet spacer general overview

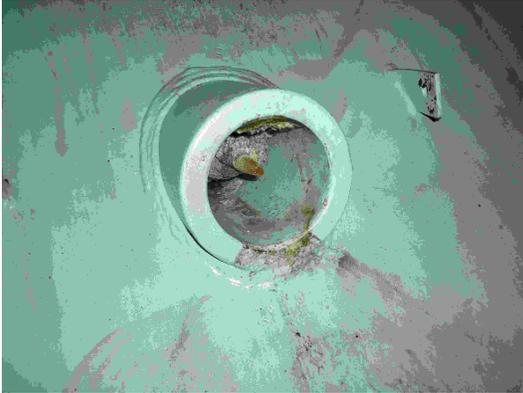
Figure: 8

consumed anode general overview

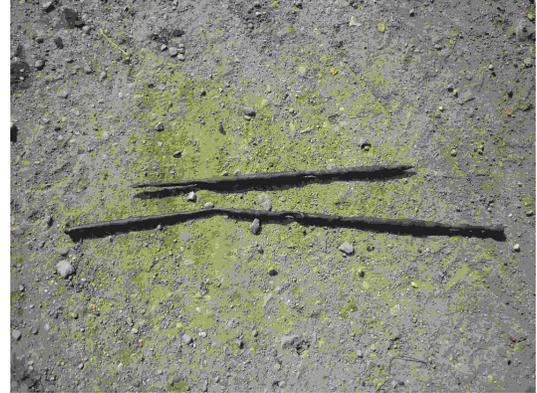
Figure: 9

anode's after being removed from vessel.

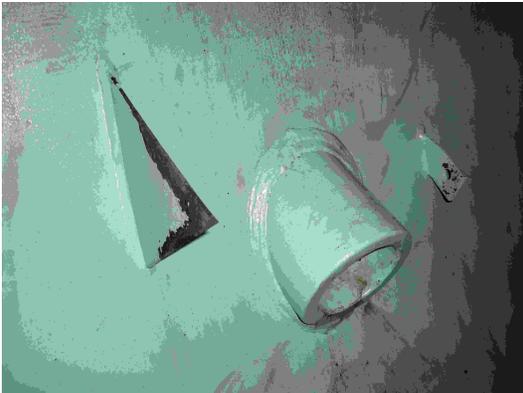
Figure: 10

nozzle general overview
