Report No: TP 000480

Client	Harvest Operations Corporation	Inspection Date	Mar 20, 2008		
Prov. Reg. #	AB 3055474	Inspection Type	VE / UT		
Equipment Type	FWKO	LSD	AB 12-15-040-08W4		
Tag/Equip.	V-130	Location	Amisk		
Status	In Service	Area	Hardisty East		
Manufacturer	PROCESS INDUSTRIES INC.	Year Built	1994		
Serial Number	94-C2883-3000	Service	Sour		
CRN #	M6442.2	Manway	None		
Comp/Unit Id		Coating	No		
Nat.Board #		Owned By	Harvest Operations Corp.		
Interim Insp'n		Interim Type			
Next Inspection	2009	Next Insp Type	VI / VE / UT / MT		
Length	480 in	Height			
Volume		RT	1	HT	No
Job No.	08-0178	Client Reference			
Foreman	Darren Olofson				
ABSA	Plant: H Vessel: K Process: W Special: B	ASME	Sec. VIII div. 1		
History Log	AB-10 submitted April 6, 2009 - Vessel owned by Harvest

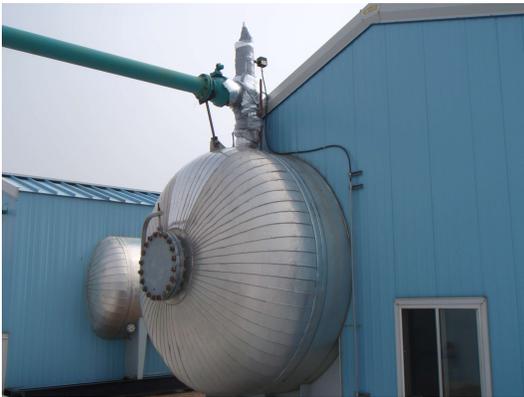
Figure: 1

North Head

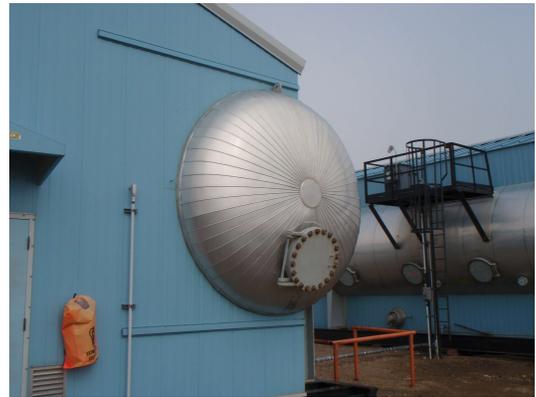
Figure: 2

South Head

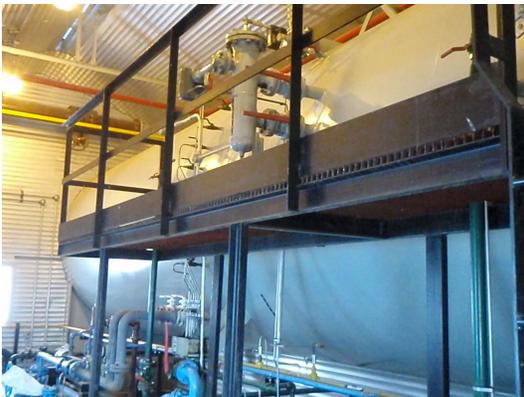
Figure: 3

Shell

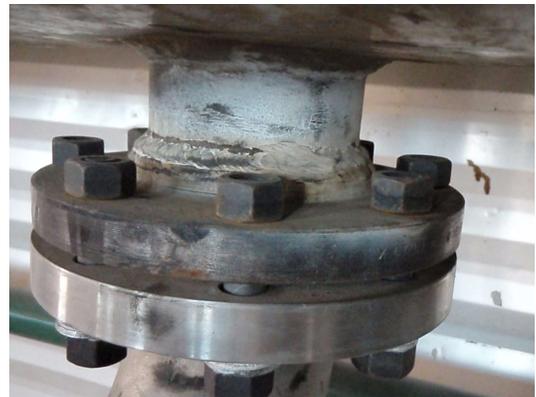
Figure: 4

Bottom Drains - Short Bolting

1. Check the anode potential or inspect the anodes for the remaining material.
2. Depending on the remaining anode life will determine the acceptance of the deferral of the internal inspection.
3. Correct the short bolting next outage.
