Report Number:			
Date:	September 23, 2015	Description:	<input checked="" type="checkbox"/> Vessel <input type="checkbox"/> Exchanger <input type="checkbox"/> Furnace <input type="checkbox"/> Boiler
Inspector:	Brian Boulet	Unit #:	Equip #:
Agent Co:	Streamline Inspection	Equip. Name:	Free Water Knockout
Owner:	Harvest	Jurisdiction #:	A3055474 CRN #: M8442.2
Region:	Alberta	Manufacturer:	Process Industries Inc
Area:	Amisk	Year Built:	1994 S/N: 94-02883-3000
		Location/LSD:	12-15-40-8W4
Scope:	A visual internal (VI) inspection was performed on all accessible shell and head surfaces, nozzles, welds, etc.		
Access:	<input checked="" type="checkbox"/> Manway <input type="checkbox"/> Hand-hole <input type="checkbox"/> Inspection Nozzle		
Opening	Gasket Surfaces:	<input checked="" type="checkbox"/> Compliant with code	Comment No Concerns
	Nozzle Tube:	<input checked="" type="checkbox"/> No pitting, erosion, etc.	Comment

INSPECTION PHOTOS

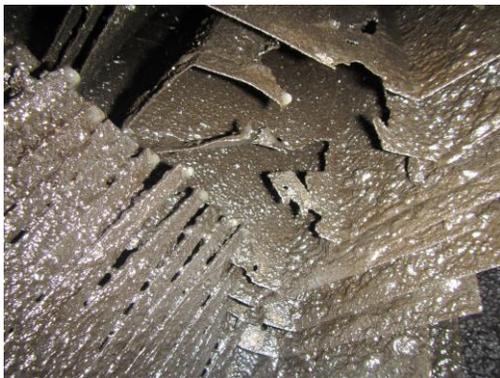
Vein Pack Corrosion

Recommended Actions:			NCR/IDR
It is recommended repairing all isolated pitting under T-min once calculated. All coating failures need to be professionally repaired after repairs are complete			
It is recommended to remove or replace the coalescer vein packs before put back into service.			
VESSEL STATUS			
Integrity Status	Suitable for Continued Service <input type="checkbox"/> Yes <input type="checkbox"/> No <input checked="" type="checkbox"/> Immediate Repairs Required <input type="checkbox"/> Future Repairs Required <input type="checkbox"/> Replace		
Inventory Status	<input type="checkbox"/> In Service <input type="checkbox"/> Out of Service <input checked="" type="checkbox"/> Surplus <input type="checkbox"/> Scrap <input type="checkbox"/> Action Items Completed

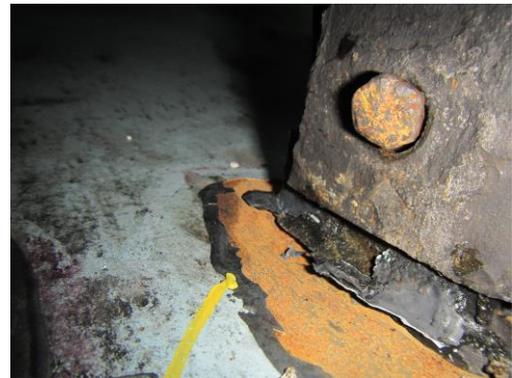
Shell and Head Surfaces	Uniform Corrosion:	<input type="checkbox"/> Insignificant amount	Comment Uniform corrosion noted around anode support brackets
	Pitting Corrosion:	<input type="checkbox"/> None noted	Comment Significant Isolated Pitting to 0.200"
	Erosion:	<input checked="" type="checkbox"/> None noted	Comment
	Mechanical Damage:	<input checked="" type="checkbox"/> None noted	Comment
Welds	Uniform Corrosion:	<input checked="" type="checkbox"/> Insignificant amount	Comment
	Pitting Corrosion:	<input checked="" type="checkbox"/> None noted	Comment
	Welding Defects:	<input checked="" type="checkbox"/> None noted	Comment
	<input type="checkbox"/> NDT was performed by:		Extent:
	Type: <input type="checkbox"/> MPI (<input type="checkbox"/> WF <input type="checkbox"/> B&W <input type="checkbox"/> Dry) <input type="checkbox"/> LPI <input type="checkbox"/> UT <input type="checkbox"/> RT <input type="checkbox"/> Other:

Inspection Summary	<p>The internal vessel was coated with epoxy, isolated areas of coating failures were observed and active corrosion was present on exposed steel surfaces measured at 0.200" around the anode support brackets. The pitting was more pronounced around attachment support brackets on the belly of the shell, four areas 0.100" and deeper. A few (4) other isolated areas measured 0.070" to 0.085". Previous pitting, repairs and MT markings were visible on the shell. The de-sand spray nozzles are intact with no concerns. The coalescer vein pack was poorly supported and fell to the bottom of the shell. The coalescor was past its service life, significant damage and corrosion was present. The inlet horse shoe deflector plates were in good condition and the access opening were not removed for inspection. The ladder rungs were secure with no concerns. The anodes were removed from service and were going to be replaced during outage. As per operation the free water knockout will be left out of service and left as a spare.</p>

0.200" Corrosion on Anode Bracket

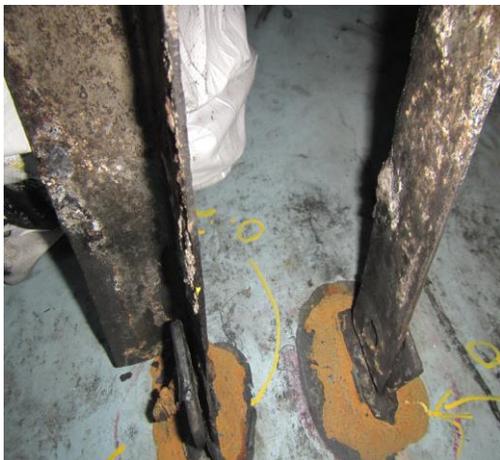
Pitting around Anode Supports

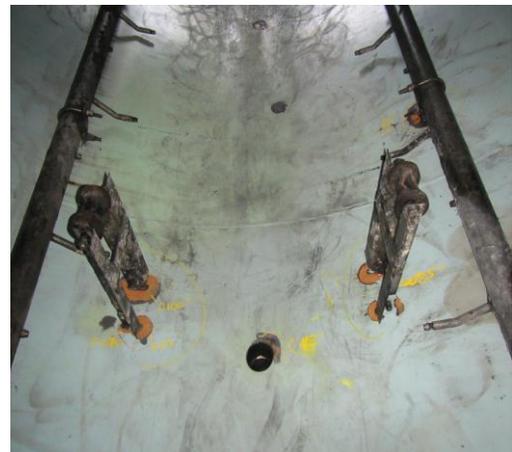
Coating Failures with Pitting

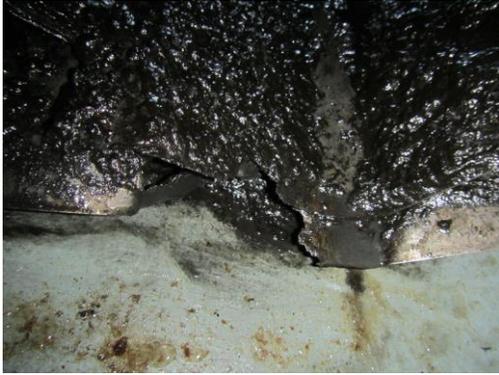
Vein Pack resting on floor

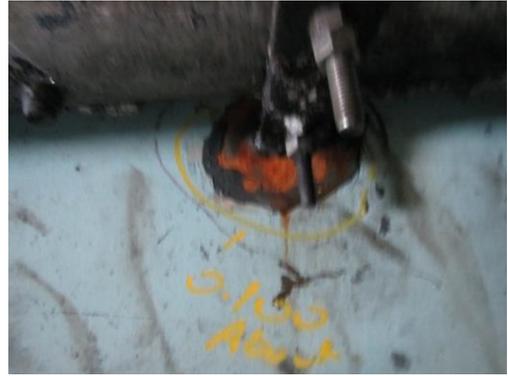
Pitting on Shell

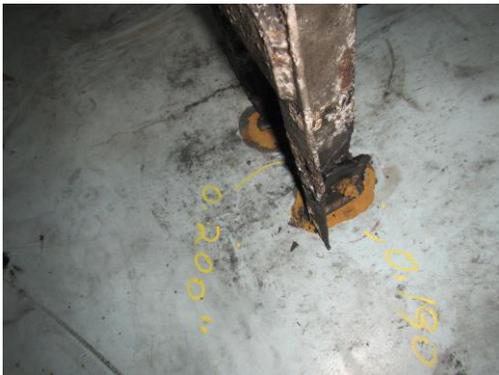
Pitting on Shell

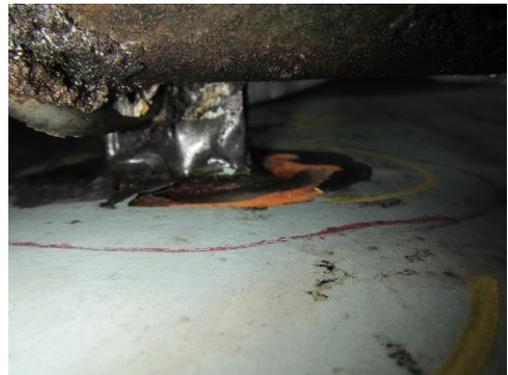
Pitting on Bottom of Shell
